1701/1702 BLOCK DIAGRAM

TROUBLESHOOTING GUIDE — 1702

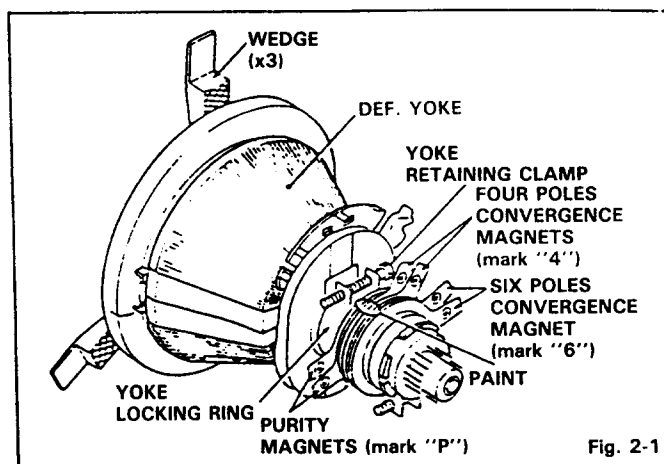
Fig. 2-1

Loosen yoke retaining clamp (Fig. 2-1). With a sharp knife, cut between the picture tube and the wedge. Remove wedges completely and clean off dried adhesive from the picture tube. PAINT is used to lock the tabs of the purity/convergence magnet assembly in place (Fig. 2-1). The paint must be removed with the end of a screwdriver before any adjustments are attempted.

11. Secure yoke retaining clamp (do not install wedges at this time).

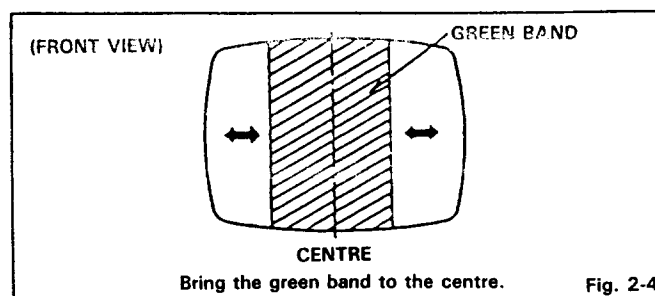
Fig. 2-3

1. Inject a Video Signal (RASTER) to the Video input terminal.
2. Let the purity tabs come in line horizontally as is shown in Fig. 2-3. A long tab should be in the same direction as the other short tab.

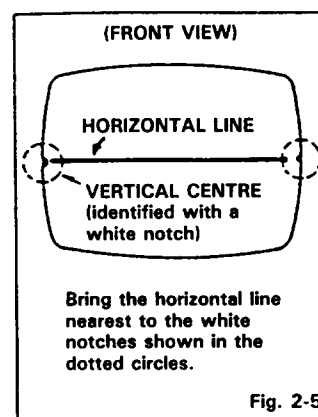
Fig. 2-4

3. Move the yoke slowly backward.
4. Turn the green cut-off control to maximum and the red and blue cut-off controls to minimum. Then adjust the screen control so that the green band can be seen best. (Fig. 2-4)

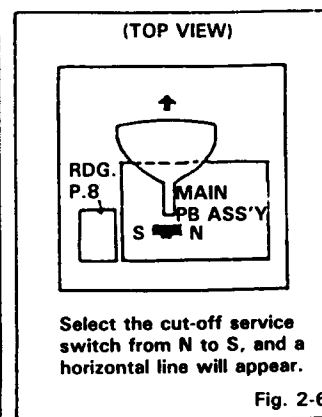
Fig. 2-5

6. Check the vertical center position by displaying a horizontal line. If incorrect, bring it to the center by rotating the two tabs, kept at an angle, together in either direction. (Fig. 2-5, 2-6)

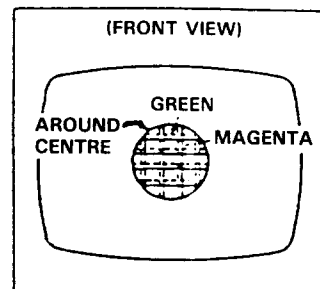
Fig. 2-8

4. Rotate the rear pair of tabs as a unit to minimize the separation of the magenta and green lines. (Fig. 2-8)
5. Adjust the spacing of the rear tabs to converge the magenta and green lines.

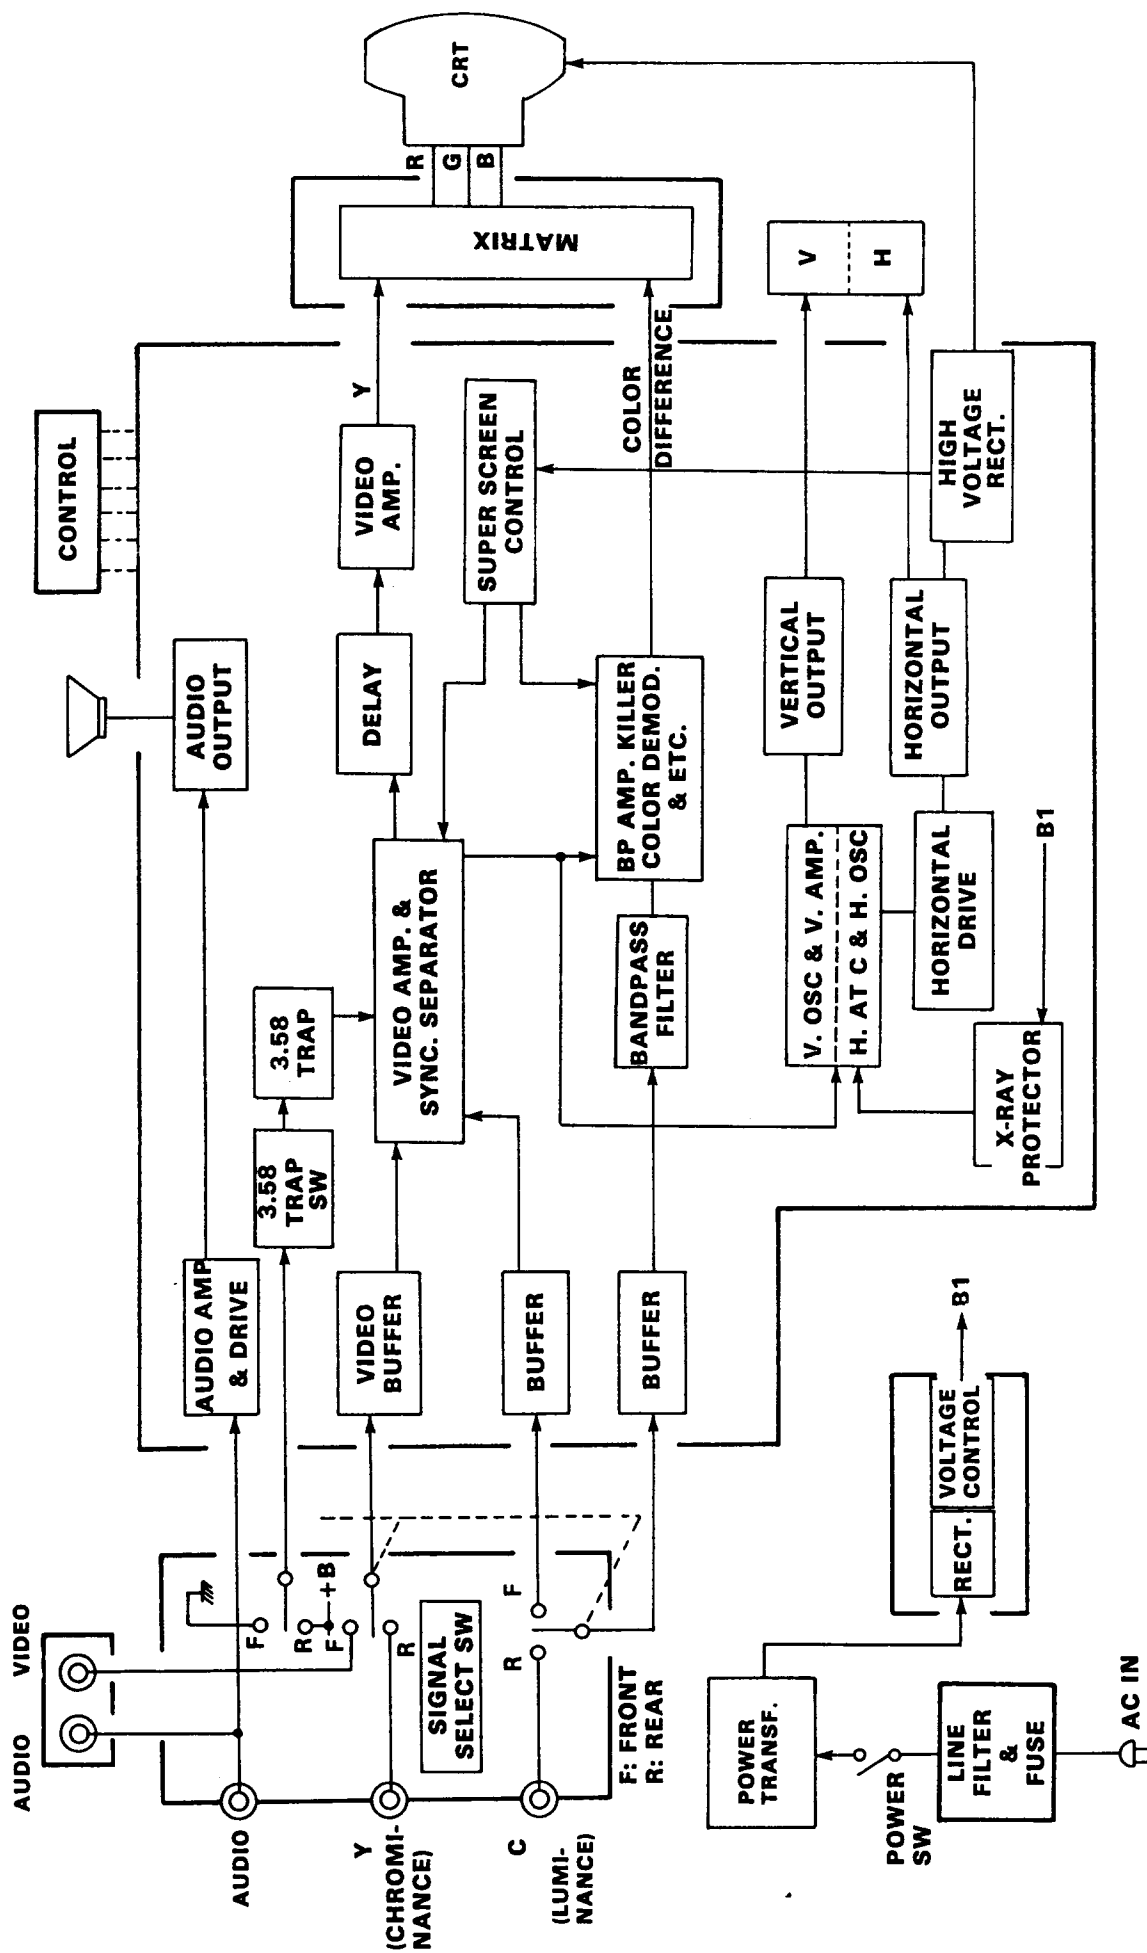
VIDEO CIRCUIT

HA11401 TROUBLE SYMPTOM OF PRESUME

- no raster no sound
- no picture
- screen is too bright
- screen is dark
- raster is bright and flyback line appears
- image quality is unsatisfactory
- faulty sync.

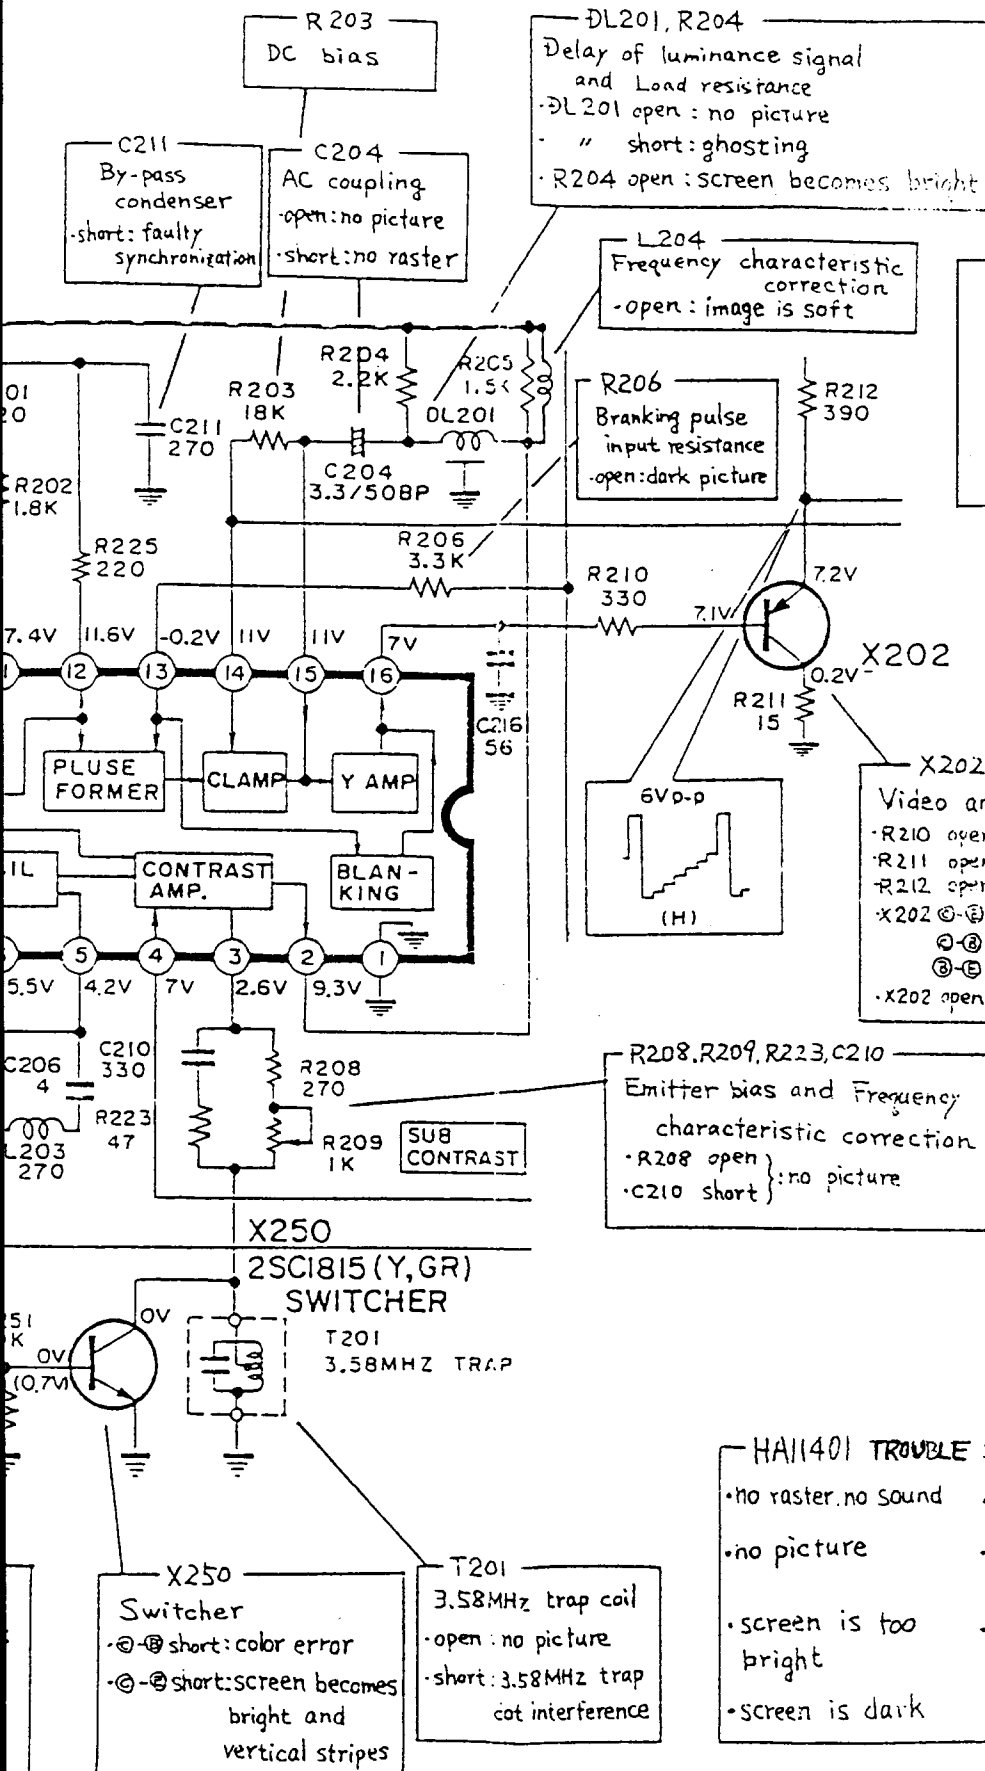
VIDEO CIRCUIT

CIRCUIT NOTES

Although, specifically written on the 1701 monitor, most circuit theories apply to the 1702 also. Refer to the 1702 schematic for differences in component values and identification.

[Cause] Malfunction of the video amplifier IC201, X202 (IC201, Q201)

The video signal and the audio signal output are supplied respectively to the video amplifier IC201 and the audio circuit IC601. Sound is had but no picture; therefore, the faulty part is IC201 and its external elements. Since pin 16 of the IC201 to the cathode of CRT is connected by a DC-coupled amplifier, a fault raising the emitter voltage of X202 (Q201) will cause the three initial output transistors to cut off, resulting in no raster.

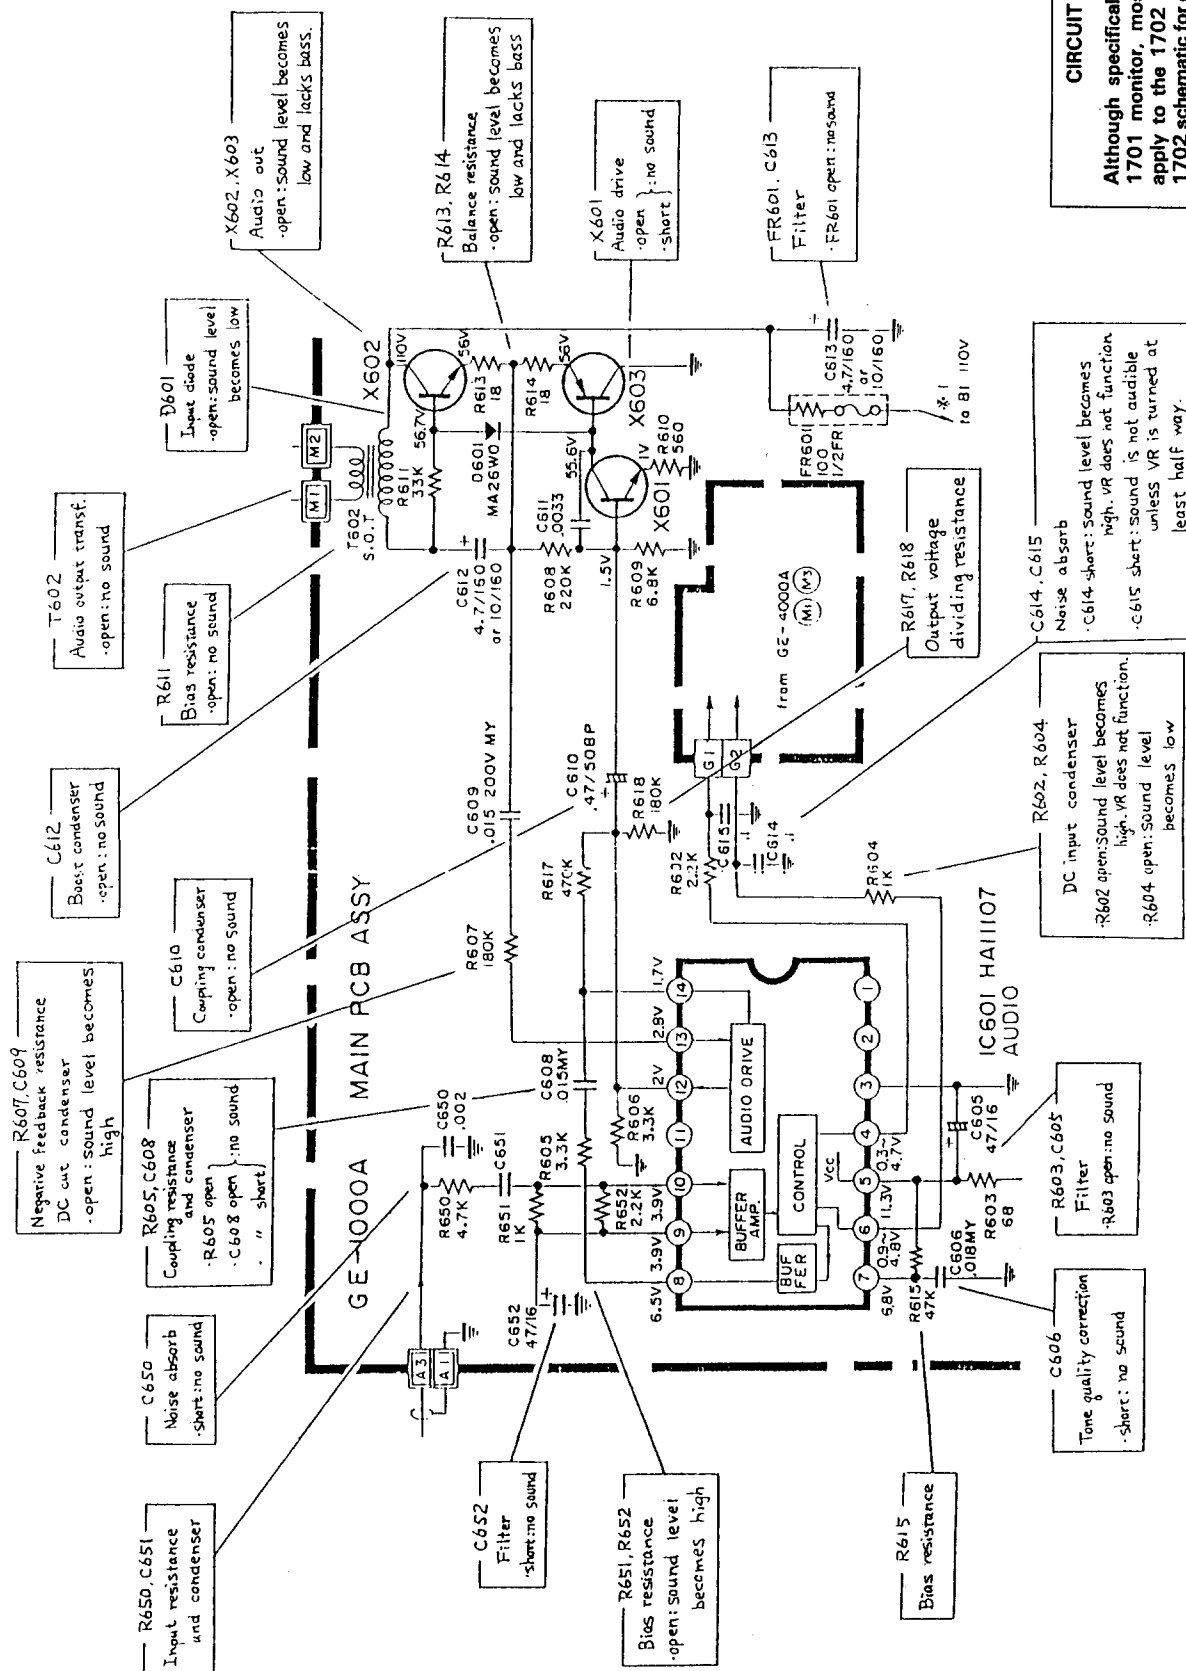
AUDIO CIRCUIT

CIRCUIT NOTES

Although specifically written on the 1701 monitor, most circuit theories apply to the 1702 also. Refer to the 1702 schematic for differences in component values and identification.

[Cause] Trouble in the audio circuit IC601, X601, X603 or X604 are faulty.

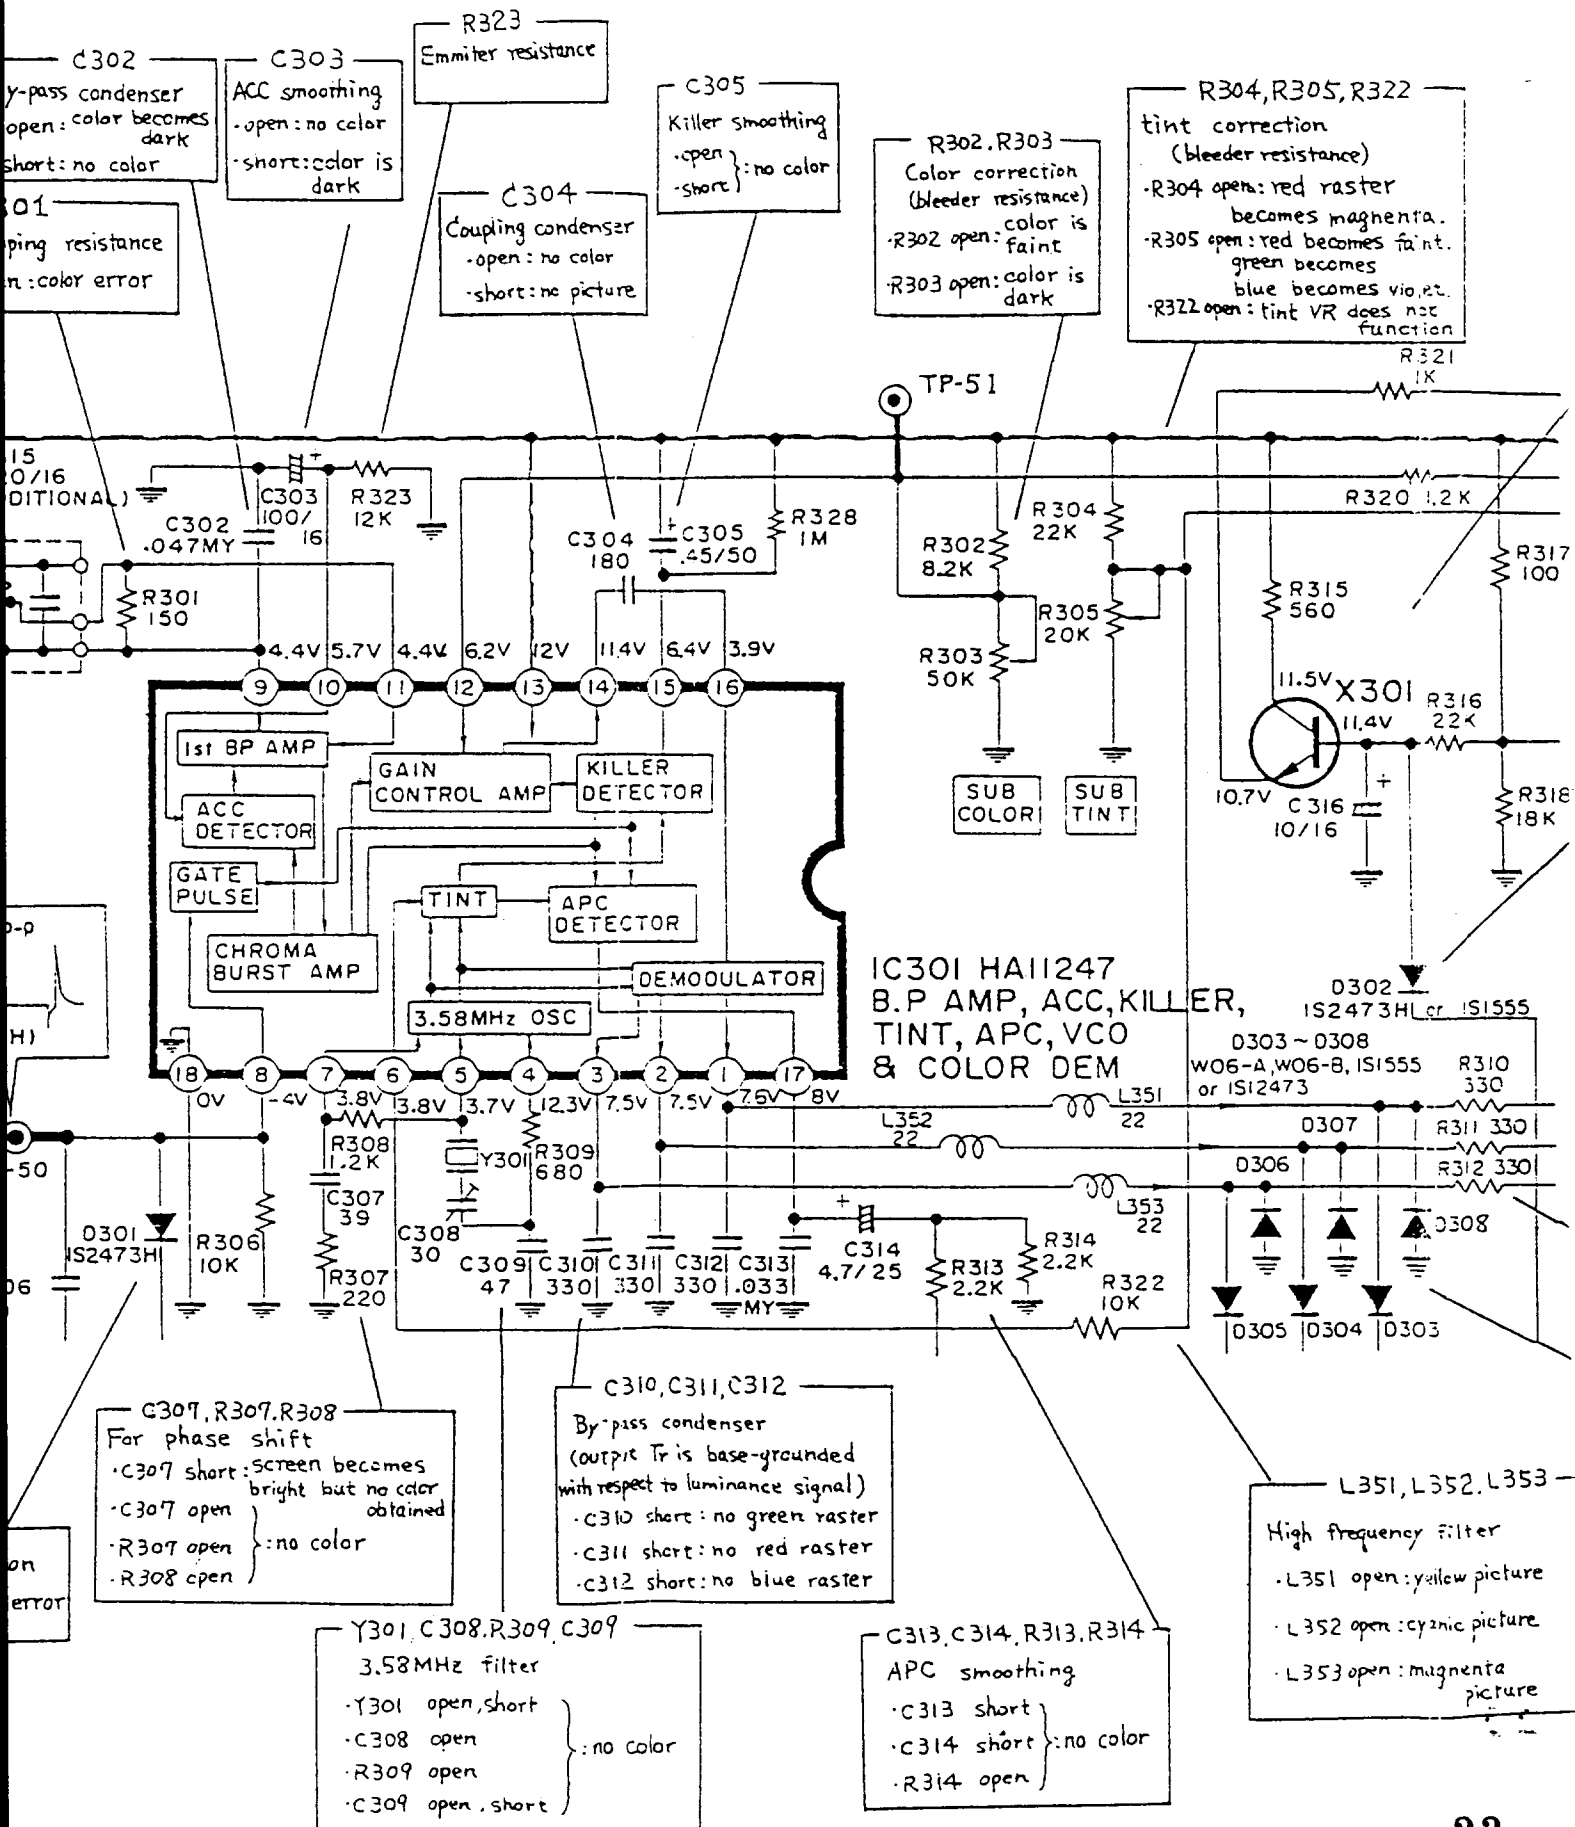
L351, L352, L353

- High frequency filter
- L351 open: yellow picture
- L352 open: cyan picture
- L353 open: magenta picture

COLOR DEM. CIRCUIT

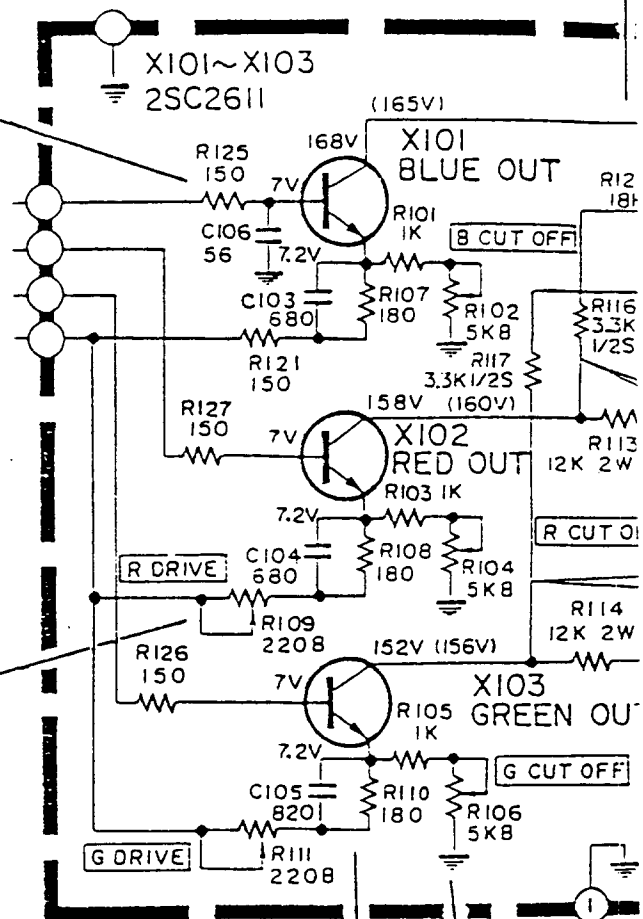
R101, R103, R102, R104, R105, R106
Emmitter resistance
Cut off adjustment

- R101 open: weak blue
- R102 open: weak blue
- R103 open: weak red
- R104 open: weak red
- R105 open: weak green
- R106 open: weak green

X101	X102	X103
blue raster	red raster	green raster
no blue raster	no red raster	no green raster

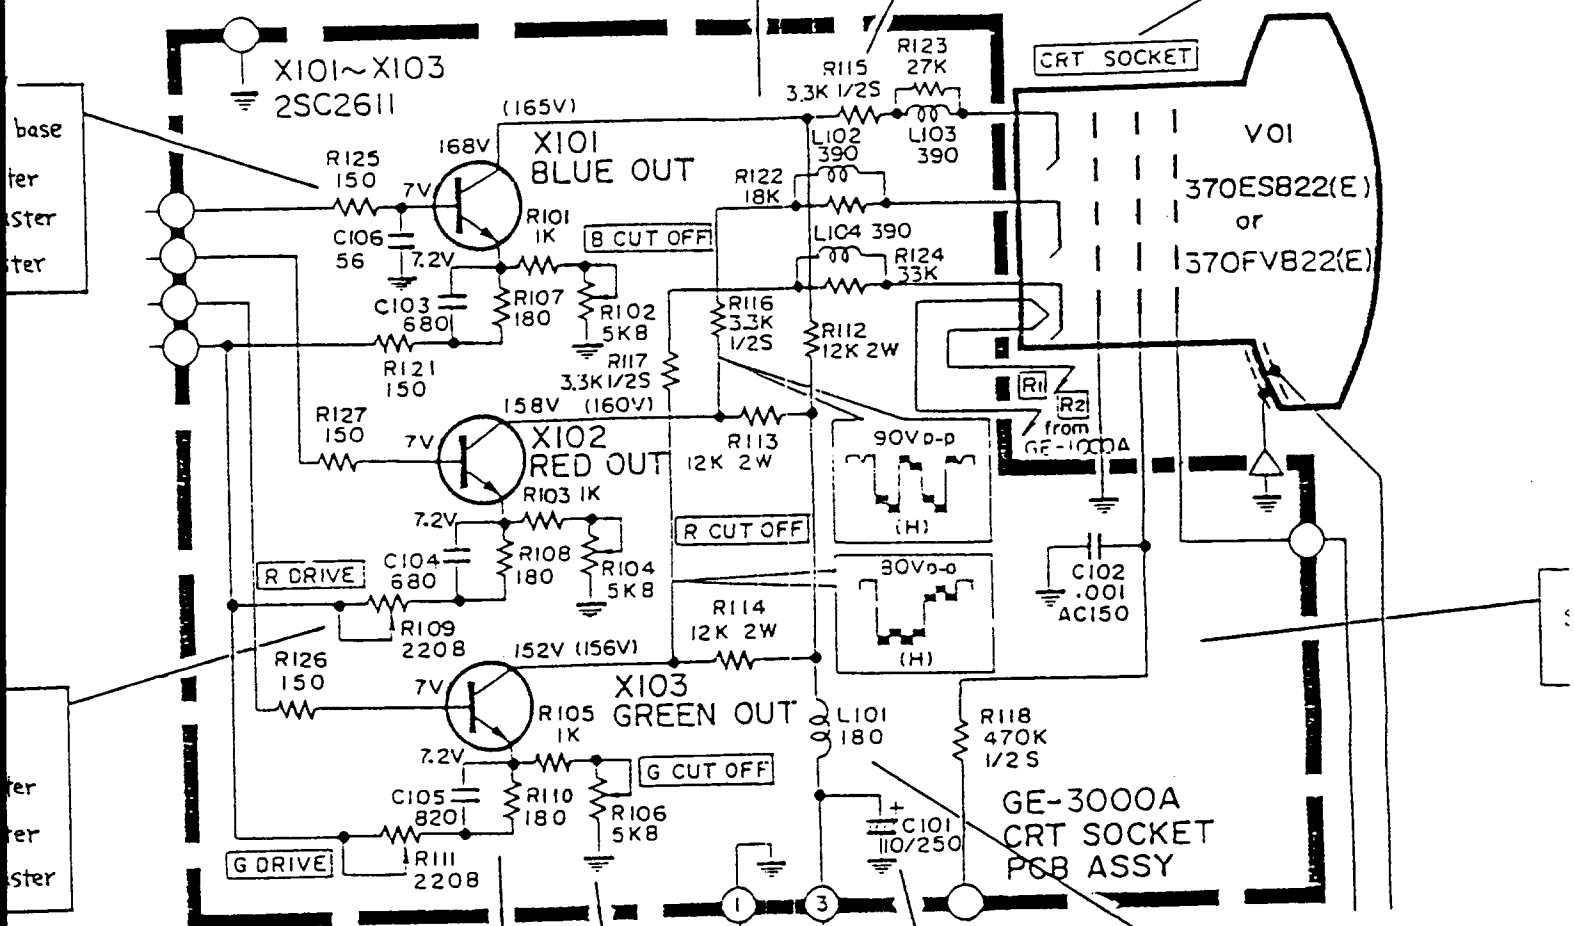
R107, R108, R110
C103, C104, C105
Emmitter resistance
Frequency characteristic correction

- R107 open: no blue raster
- R108 open: no red raster
- R110 open: no green raster
- C103 short: screen of blue saturate
- C104 short: screen of red saturate
- C105 short: screen of green saturate

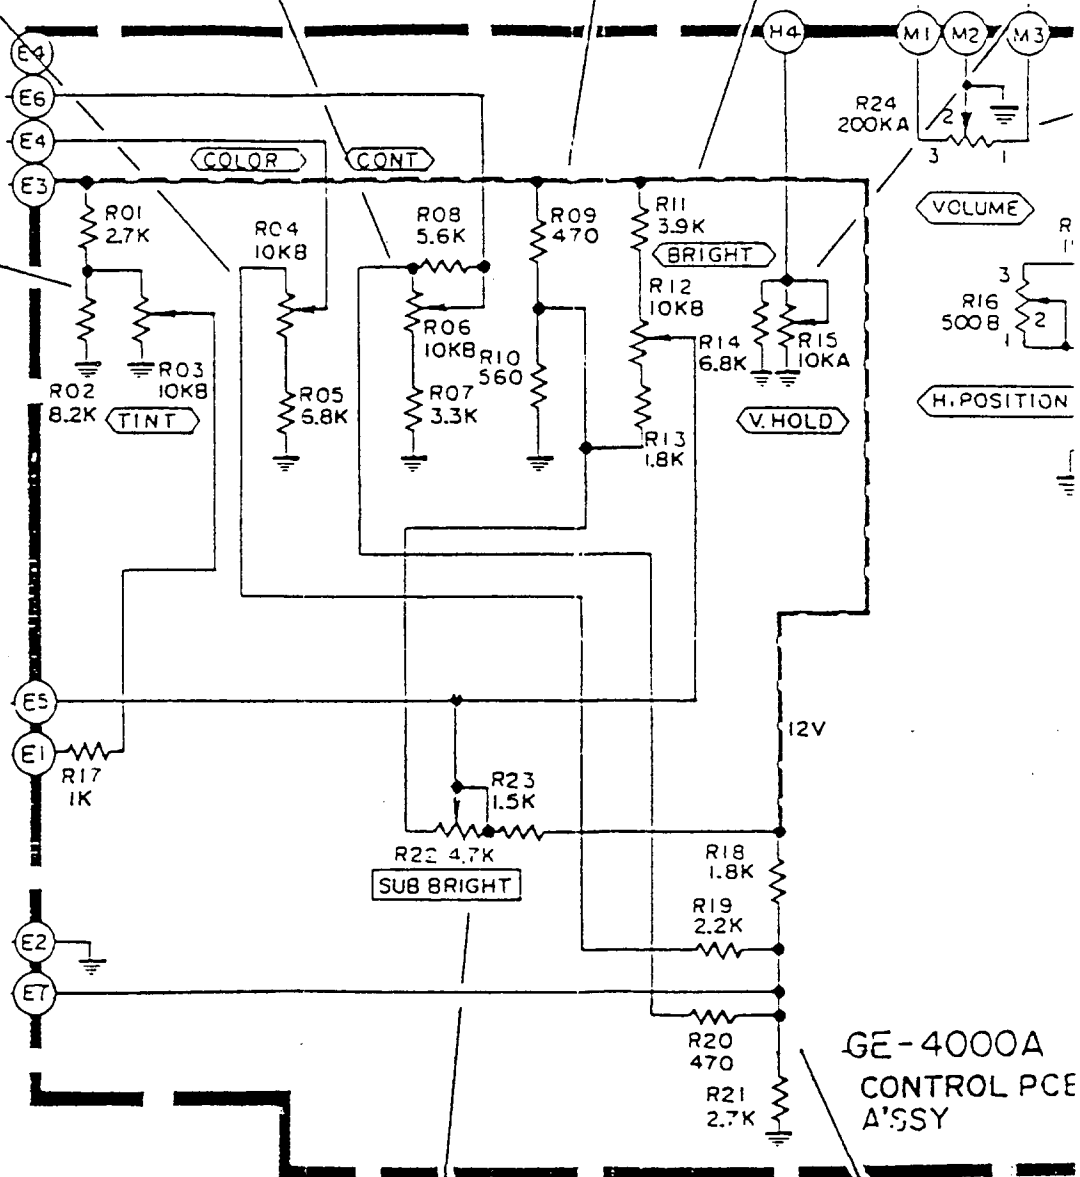
R22, R23
Sub bright control
R23 open: no raster

R18, R19, R20, R21
Bleeder resistance
R18 open } screen becomes
R19 open } slightly dark.
R20 open: color is faint.
R21 open: screen becomes
slightly bright.

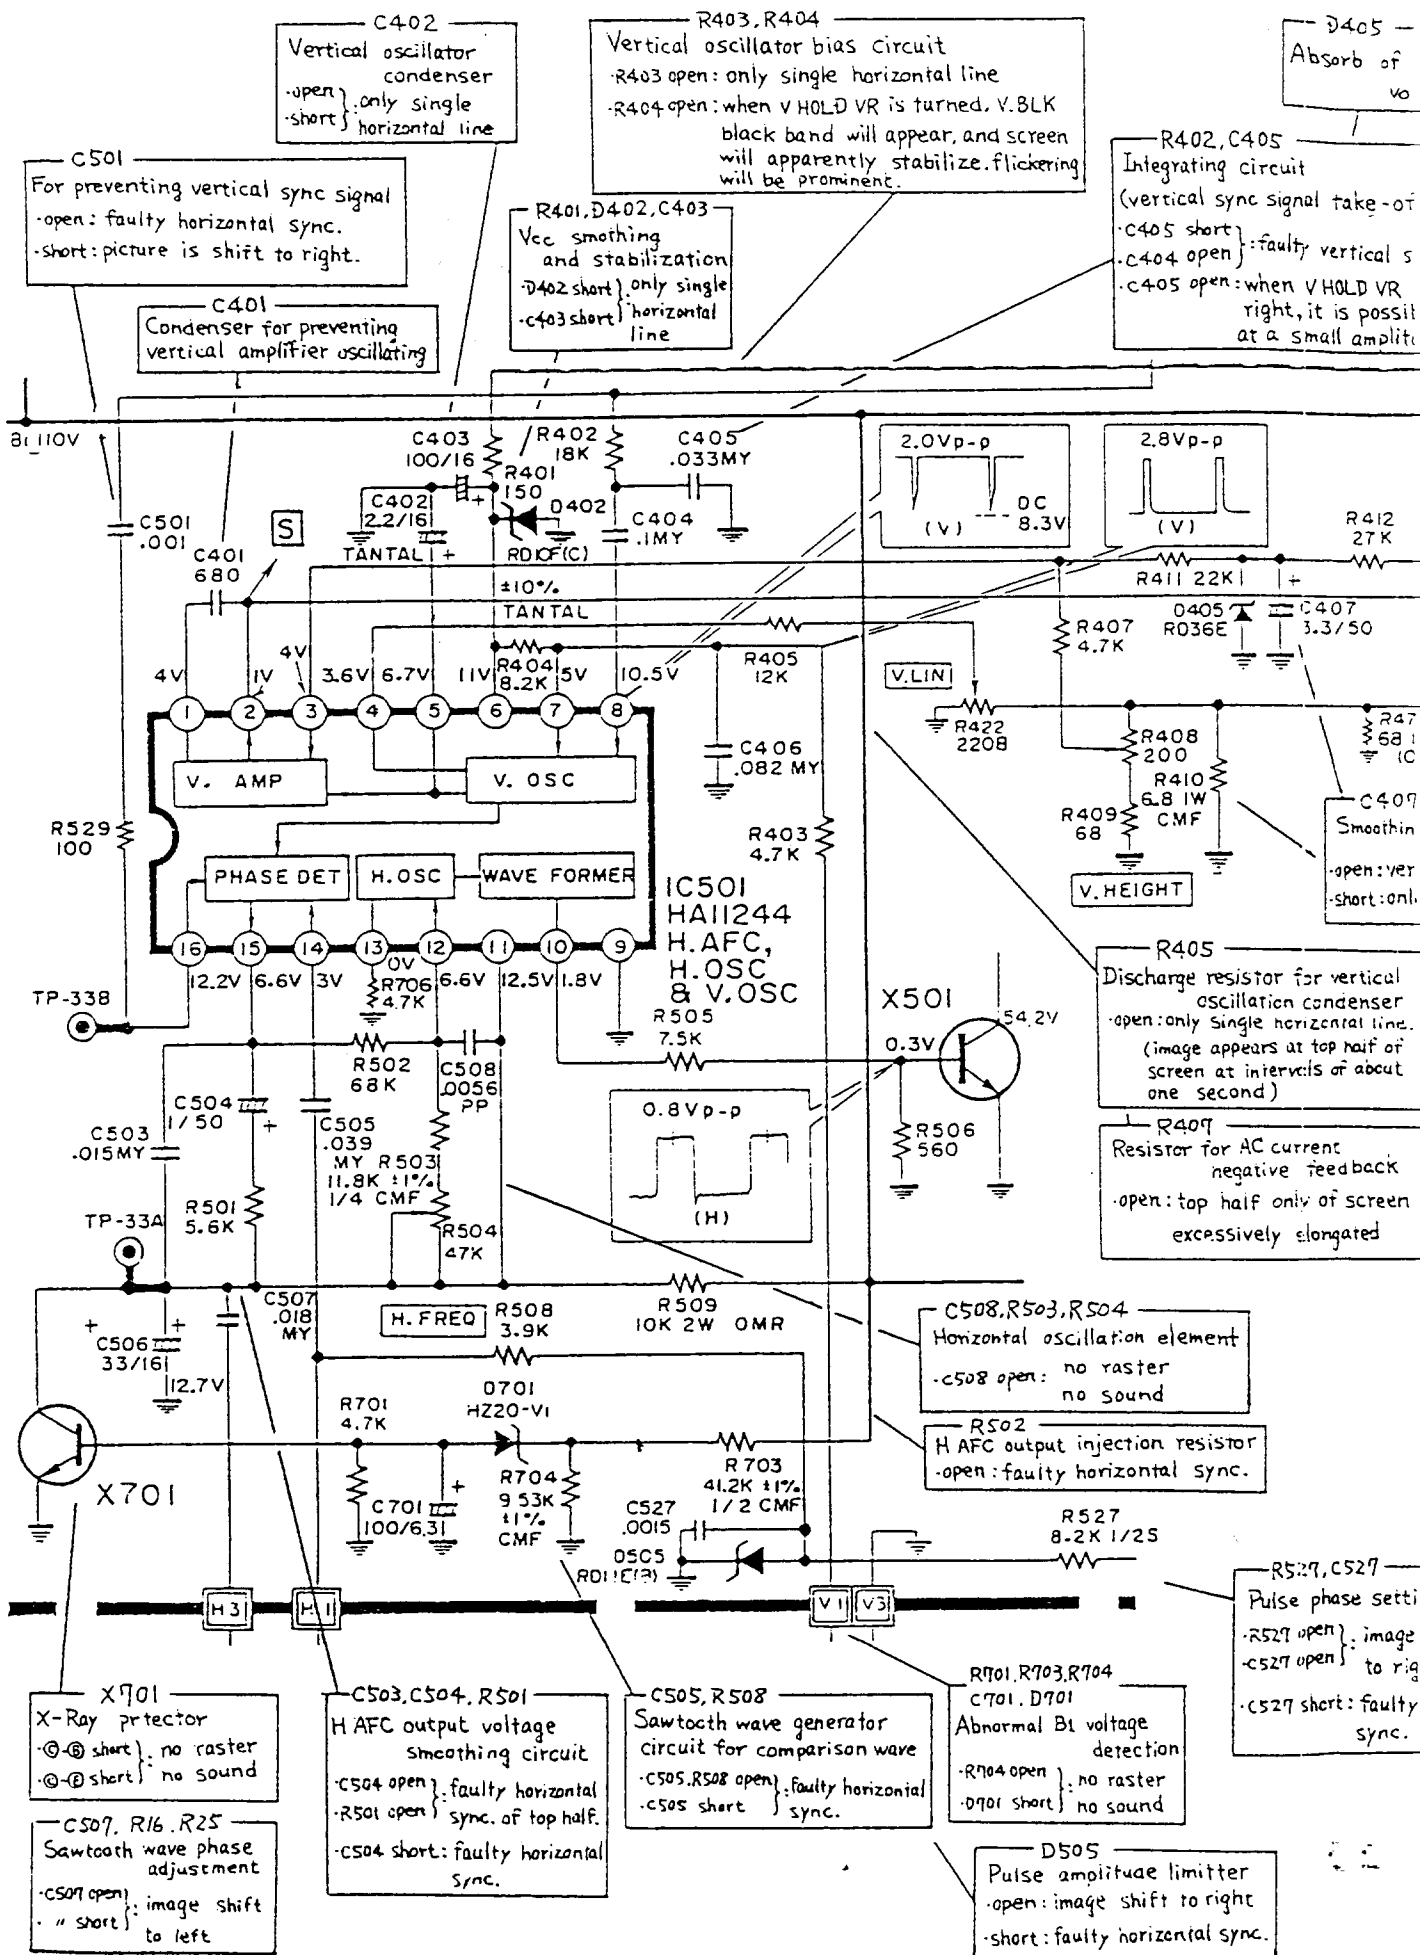
R403, R404
Vertical oscillator bias circuit
R403 open: only single horizontal line
R404 open: when V HOLD VR is turned, V.BLK black band will appear, and screen will apparently stabilize. flickering will be prominent.

C403
Vertical sync signal take-off
only single horizontal line

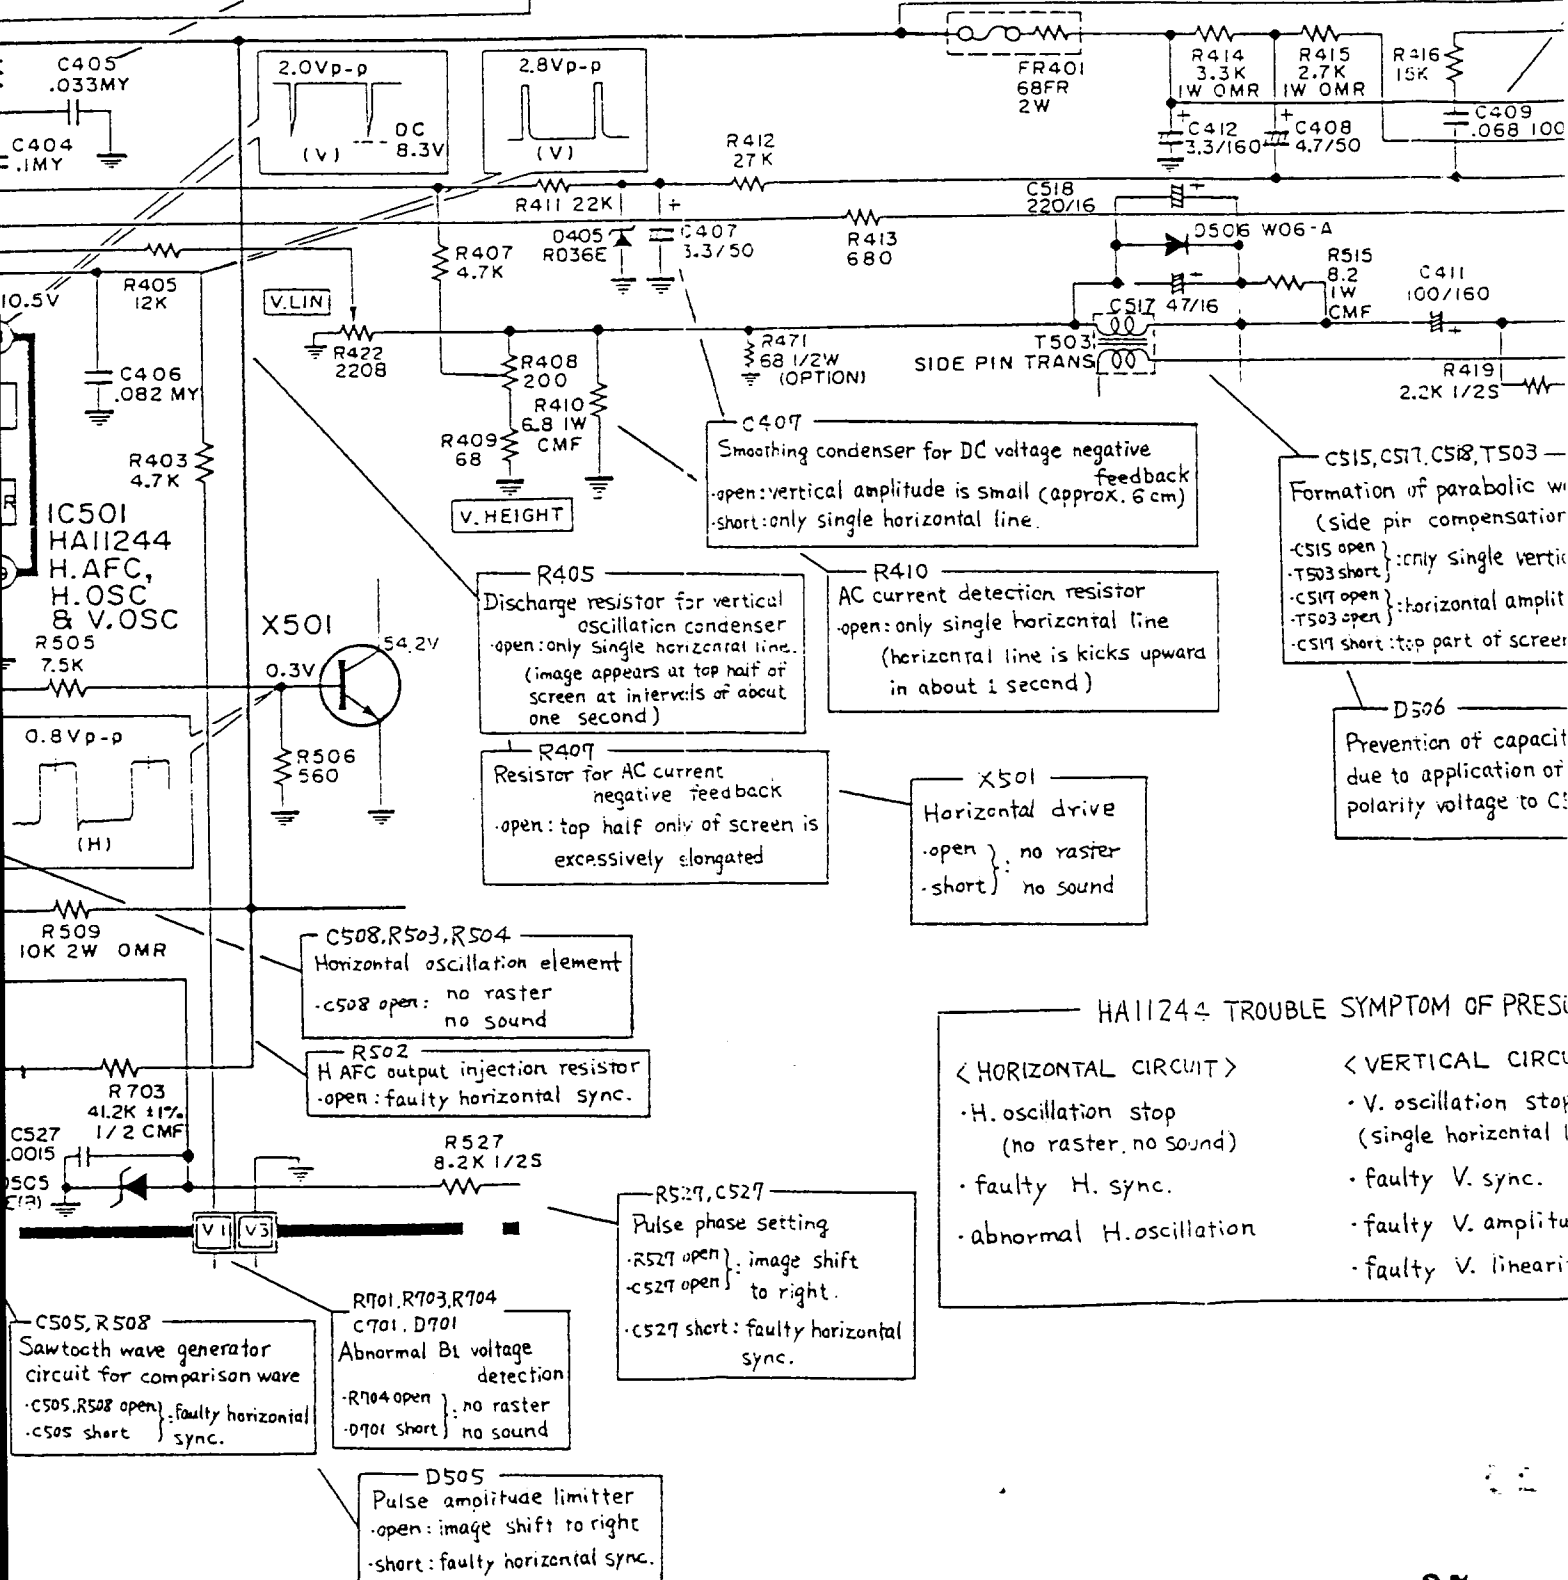
FR401, C412
R414, C408
Smoothing
-FR401 open: vertical amplitude is small. (approx. 1.5cm)
-R414 open: vertical amplitude is small. (approx. 2cm)

R415
Base bias resistance of X401
open: vertical amplitude is small. (approx. 2cm)

H. OSC, V. OSC & V. OUT CIRCUIT

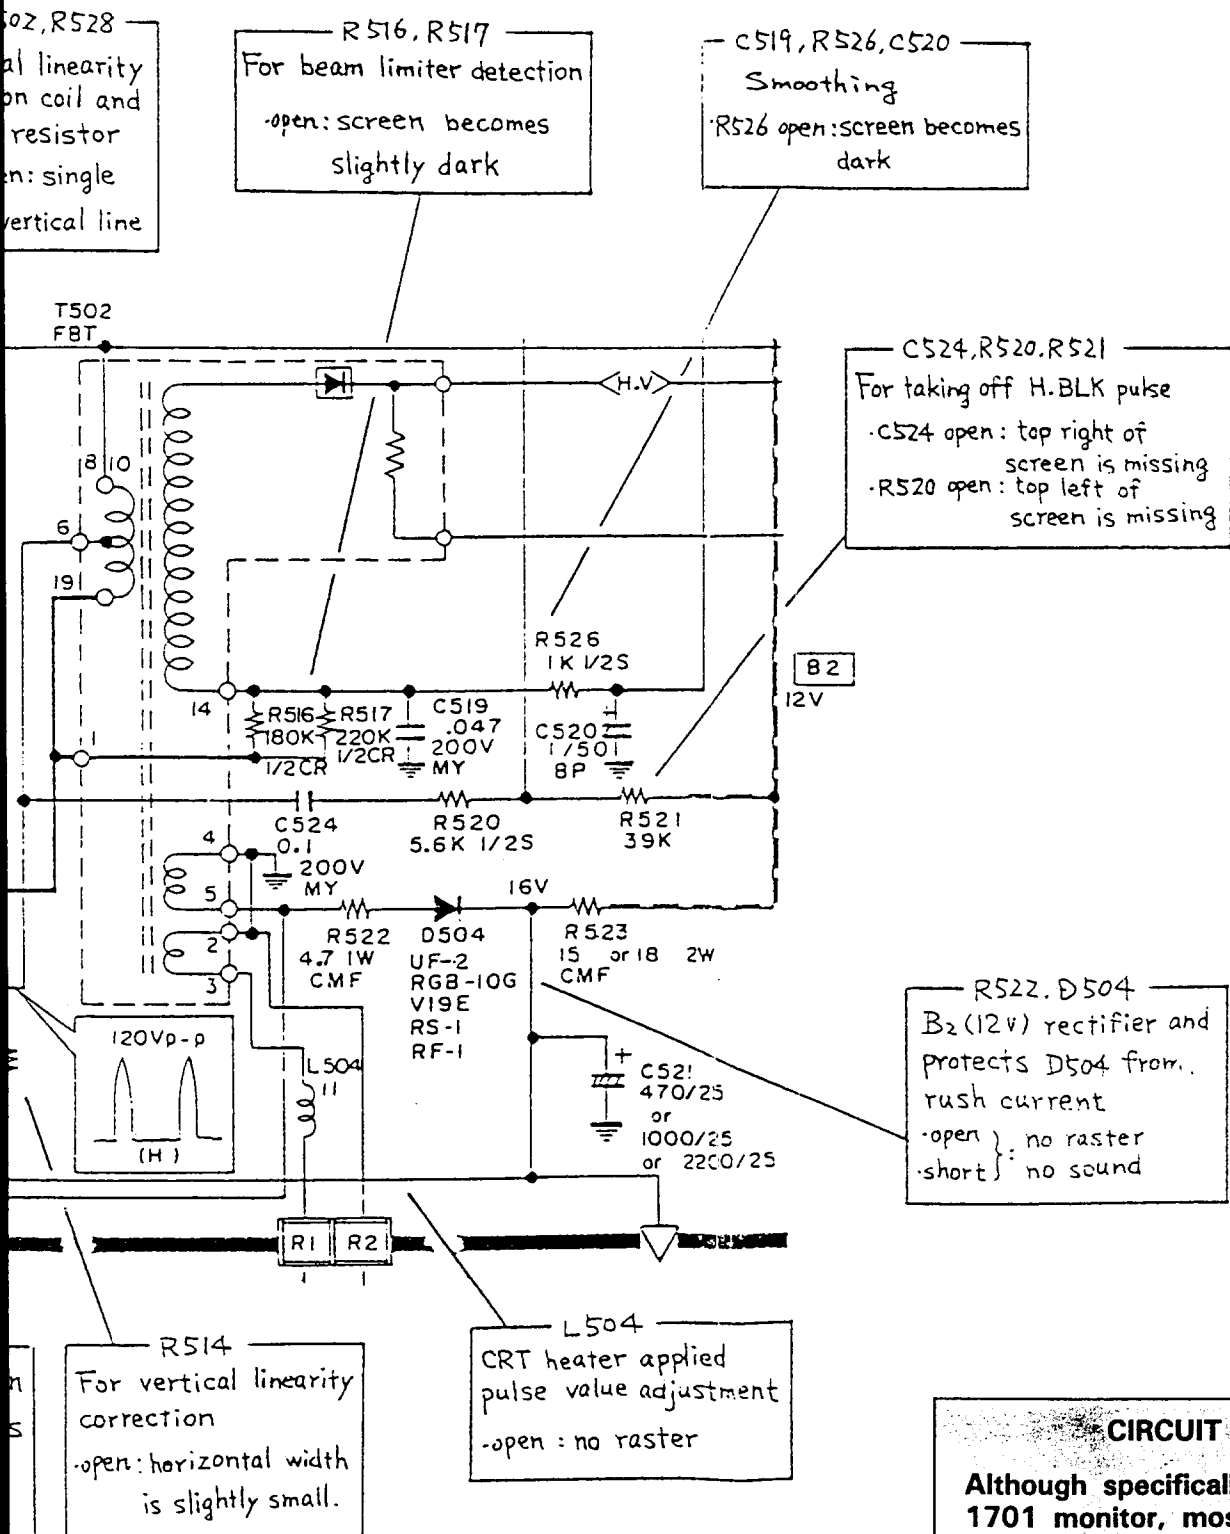
HORIZONTAL OUTPUT CIRCUIT

CIRCUIT NOTES

Although specifically written on the 1701 monitor, most circuit theories apply to the 1702 also. Refer to the 1702 schematic for differences in component values and identification.

[Cause] Horizontal deflection circuit

1. As long as normal B_H 160V is generated, the horizontal output circuit properly operates, producing pulses during the flyback period of the saw-tooth wave current passing through the horizontal deflection coil. If a problem is found with normal B_H voltage, the problem area should be the secondary coil of the flyback transformer.

3. AC voltage is measured between the collector and ground of X501 (Q521) horizontal drive as shown. When the specified voltage is shown on the meter, the horizontal output circuit is the problem; while, when there is no voltage indication, the trouble is in some element(s) preceding X501 (Q521). Check if those transistors and ICs are damaged using a voltage measurement.
